TEXAS PROPERTY INSPECTION TREC 7-6

10928 Cardigan Dr El Paso, TX 79936

PROPERTY INSPECTION REPORT FORM

Raul Xicali	11/04/2024 1:00 pm		
Name of Client	Date of Inspection		
10928 Cardigan Dr, El Paso, TX 79936			
Address of Inspected Property			
Chad Middleton, Integrity Termite	TREC License #22955, null		
Name of Inspector	TREC License #		
Name of Sponsor (if applicable)	TREC License #

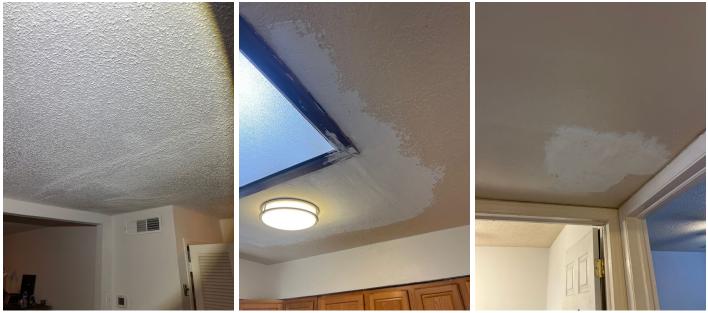
Various Locations

Signs of Previous Repairs or Freshly Painted in one or more areas of the home. It is beyond the scope of this inspection to determine if all repairs were conducted using normal building practices. Paint can hide more severe issues that can not be seen by the inspector. We strongly recommend further evaluation of the repaired area and reason for repair.

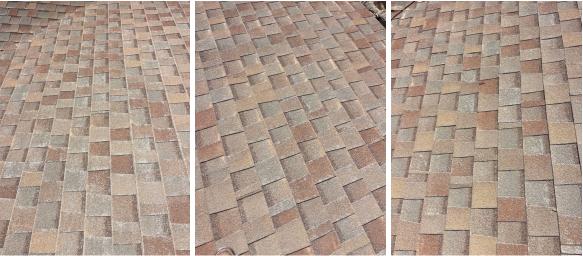
Granular loss in one or more areas - Over time shingles will have granular loss and this is a typical finding - Shingles with granular loss are performing - Recommend consult with roofing company to discuss if repairs are necessary.

Recommendation: Contact a qualified professional.

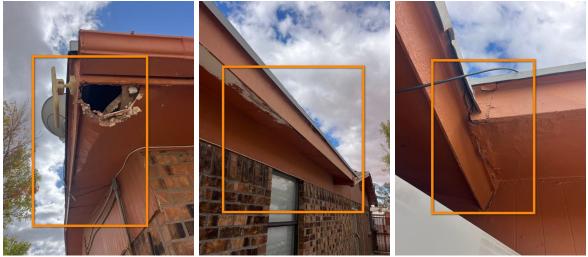
Left Side of Structure Rear of Structure Fascia / Soffit Trim boards are damaged - Recommend repair.

Recommendation: Contact a qualified roofing professional.

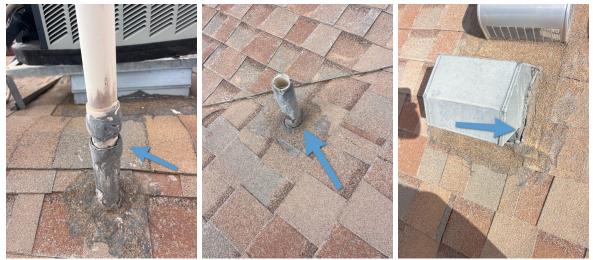
Exposed sealant missing and / or cracks are present at one or more roof penetrations and / or at intersections with exterior walls - Recommend adding sealant and resealing of all cracks.

Recommendation: Contact a qualified professional.

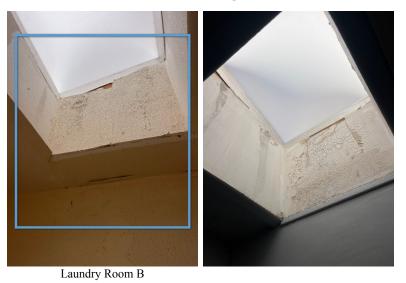
Water stains on walls and minor water damage. Area checked for moisture with negative results. Inspector unable to determine past water source at time of inspection. Recommend further evaluation.

Recommendation: Recommend monitoring.

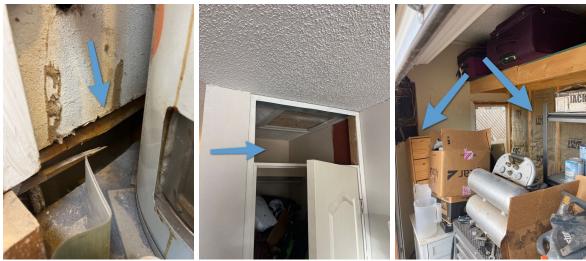
Sheet rock / drywall missing or damaged in one or more areas.

Recommendation: Contact a qualified handyman.

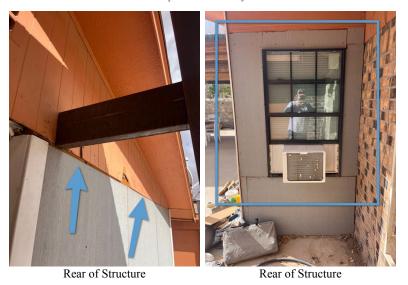
Voids or Gaps at wall penetrations or other areas. Recommend they be sealed to prevent water intrusion. Home owner should check these areas periodically and reseal when necessary.

Recommendation: Contact a qualified handyman.

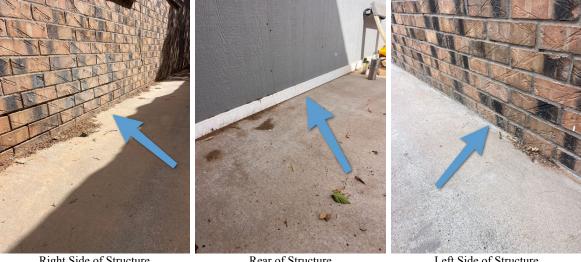
Inadequate clearance between siding and grade (The Ground). Siding has less than 2" clearance to concrete and / or grade. New home construction is required to have 4 to 8 inches of clearance. For older homes this is an as-built condition and remediation is not required. Recommend monitoring periodically to determine if standing water is affecting the siding.

Recommendation: Recommend monitoring.

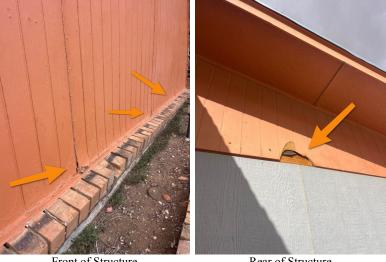
In Need of Repair Front of Structure Rear of Structure Wood Trim / Wood Siding is damaged - In need of repair.

Recommendation: Contact a qualified general contractor.

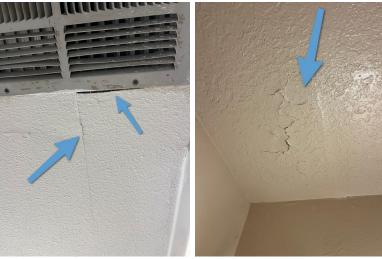
Minor cracking in ceiling (Sheetrock). A typical finding and not believed to be foundation related and is a cosmetic issue. Recommend patch and paint the area.

Recommendation: Contact a qualified handyman.

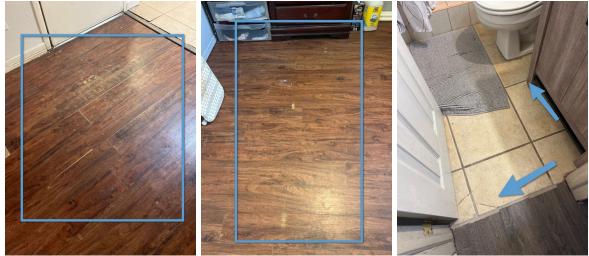
Floor Tiles / Wood / Linoleum cracks were observed - Floors are performing and these appear minor in nature.

Recommendation: Contact a qualified professional.

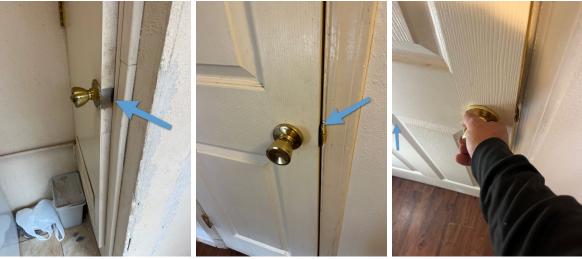
Observations / Maintenance / Repair Recommended Various Locations
Door does not latch.

Recommendation: Contact a qualified handyman.

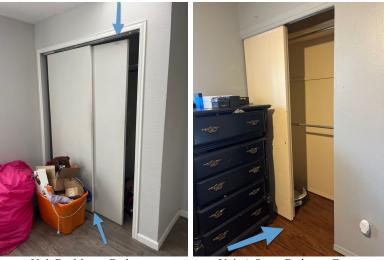
One or more closet doors do not operate properly and / or are missing hardware.

Recommendation: Contact a qualified handyman.

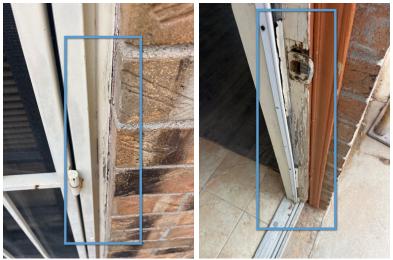
Wood Door Framing and Trim - Paint was noted to be weathered and peeling on wood trim in various areas. Sealing or repainting is recommended to insure a longer life of the trim materials

Recommendation: Contact a qualified handyman.

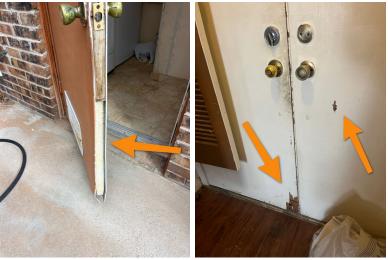
One or more exterior doors are damaged, do not function properly, and are in need of repair.

Recommendation: Contact a qualified general contractor.

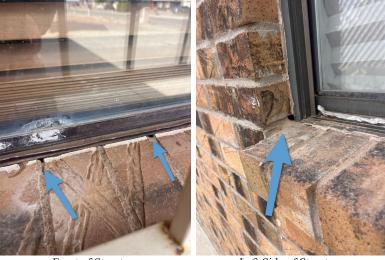
Cracking or Missing grout / sealant around exterior window frame. Recommend sealing to prevent water intrusion

Recommendation: Contact a qualified handyman.

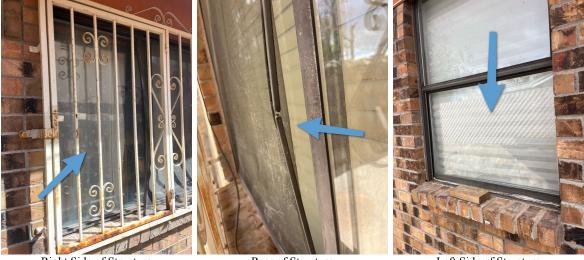
Observations / Maintenance / Repair Recommended Various Locations
Window Screens are damaged or missing.

Recommendation: Contact a qualified handyman.

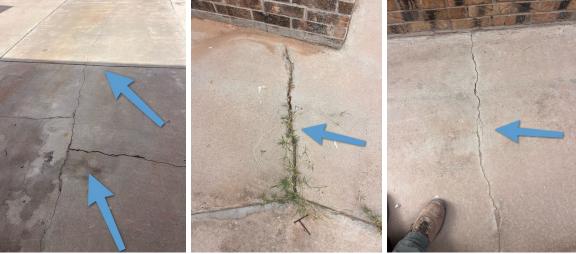
Typical cracking in concrete. This is a very common finding and should not be a major concern. Monitor and seal if necessary.

Recommendation: Recommend monitoring.

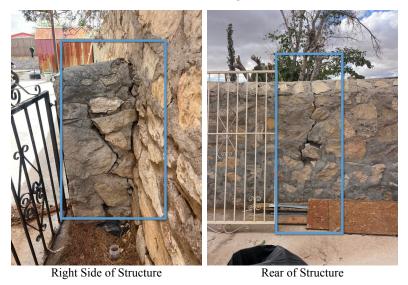
Cracks / voids in rock wall. Recommend repair. Inspector does not take core samples of the mortar. You should expect to conduct maintenance on all rock walls.

Recommendation: Recommend monitoring.

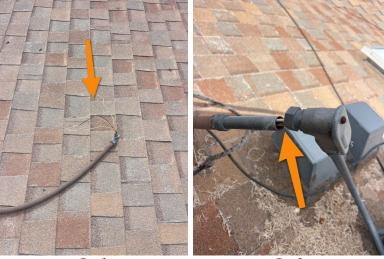
All wire connections & charged wires with exposed ends and splices should be covered in junction boxes for safety. Recommend a qualified electrician correct.

Recommendation: Contact a qualified electrical contractor.

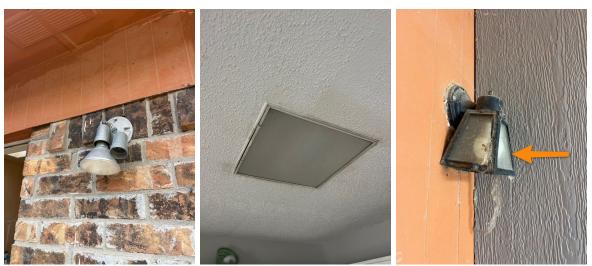
One or more lights are not operating. This could be as simple as a light bulb. (Inspectors do no carry light bulbs) In need of repair.

Recommendation: Contact a qualified electrical contractor.

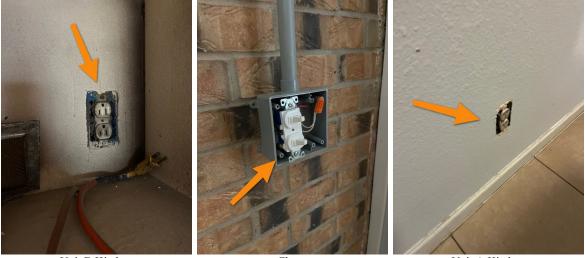
One or more receptacles are missing a cover plate. This causes short and shock risk. Recommend installation of cover plates.

Recommendation: Contact a qualified electrical contractor.

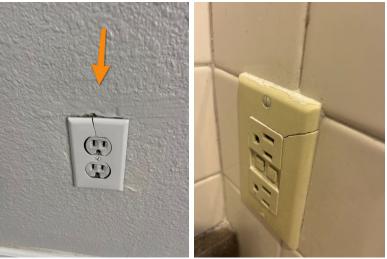
One or more receptacles have a damaged cover plate. Recommend replacement.

Recommendation: Contact a qualified electrical contractor.

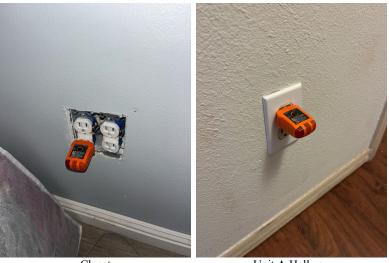
Test indicate no power at various outlets - In need of repair.

Recommendation: Contact a qualified electrical contractor.

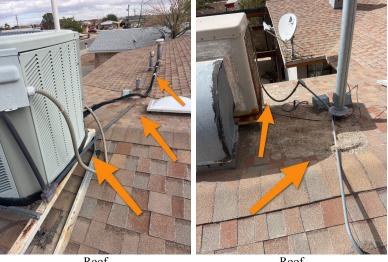
Conduit on Exterior Walls and / or Roof not properly secured - All conduit should secured.

Recommendation: Contact a qualified electrical contractor.

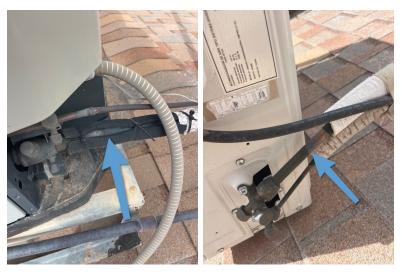
AC Compressor Unit on roof not properly secured to roof or jack stand. Recommend service.

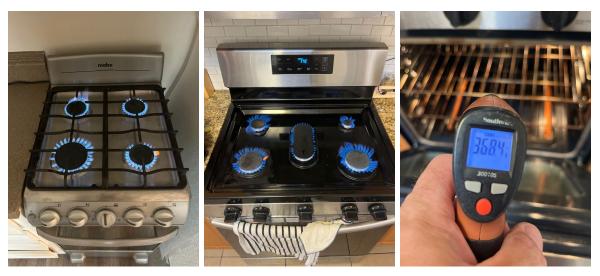
1: Oven - Would not turn on Observations / Maintenance / Repair Recommended Would not turn on using normal controls.

Recommendation: Contact a qualified appliance repair professional.
