TEXAS PROPERTY INSPECTION TREC 7-6

10928 Cardigan Dr El Paso, TX 79936

PROPERTY INSPECTION REPORT FORM

Raul Xicali	11/04/2024 1:00 pm		
Name of Client	Date of Inspection		
10928 Cardigan Dr, El Paso, TX 79936			
Address of Inspected Property			
Chad Middleton, Integrity Termite	TREC License #22955, null		
Name of Inspector	TREC License #		
Name of Sponsor (if applicable)	TREC License #

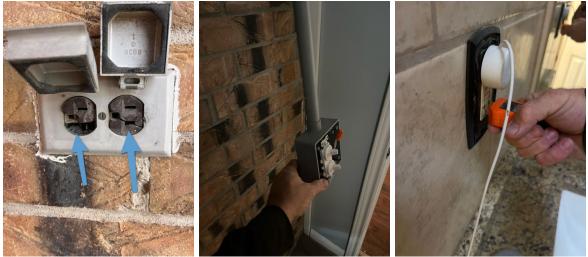
Observations / Maintenance / Repair Recommended Various Locations
 Outlet is not attached properly and or Damaged. In need of repair.

Recommendation: Contact a qualified electrical contractor.

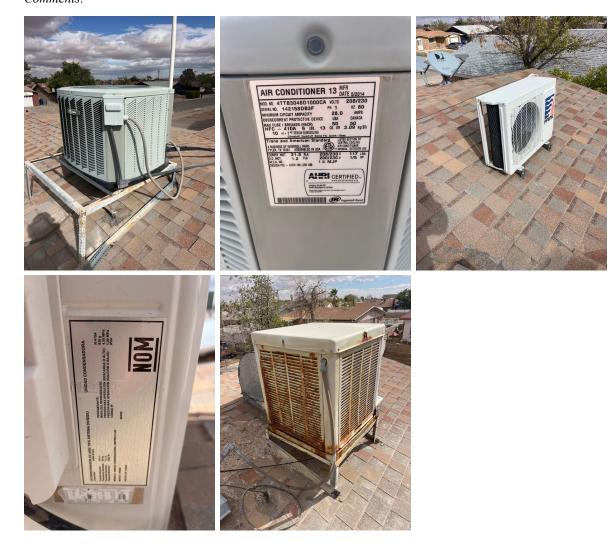
System has extensive rust and corrosion. In need of repair

Recommendation: Contact a qualified heating and cooling contractor

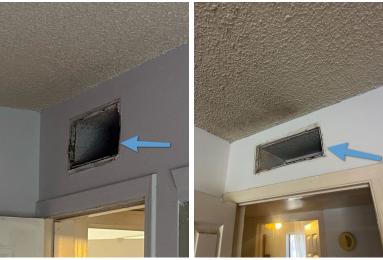
Unit A Spare Bedroom Rear

Observations / Maintenance / Repair Recommended One or more register covers missing

Recommendation: Contact a qualified professional.

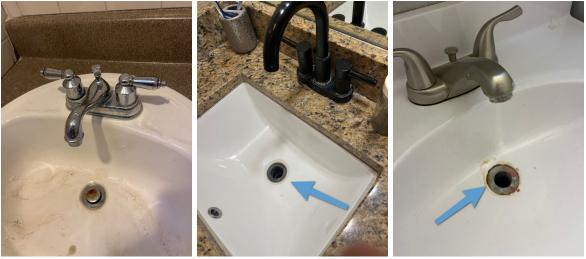
Observations / Maintenance / Repair Recommended Various Locations
Drain stop inoperable, missing or damaged.

Recommendation: Contact a handyman or DIY project

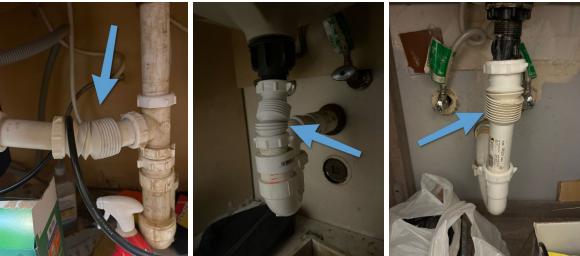
Accordion-style piping is being used for plumbing. Typically, this is not considered a permanent solution. Recommend monitor for leaks routinely.

Recommendation: Recommend monitoring.

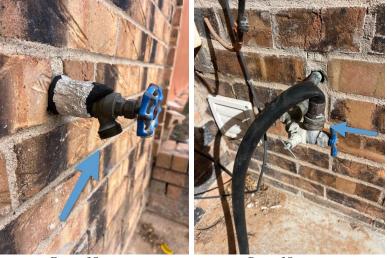
Exterior hose bibs do not have back-flow prevention (Anti-Siphon). Back-Flow devices are easily purchased at hardware stores and are easy to install. They prevent water from flowing back into house supply. Typical finding on older homes. Back-Flow devices can be purchased at big box stores for less than \$5.00 and are easy to install.

Recommendation: Contact a handyman or DIY project

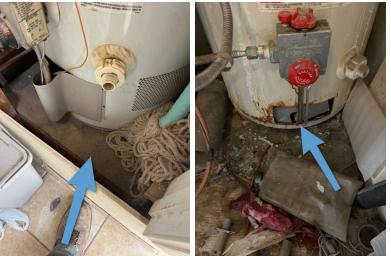
Lack of drain pan and / or drain system - If water heater leaks it will drain into the home. Typical finding in older homes. We recommend a 9 Volt moisture alarm readily available from most plumbing supply stores or online.

Recommendation: Contact a qualified plumbing contractor.

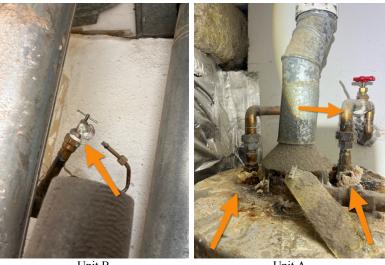
Corrosion and / or signs of an intermittent leak at isolation valve or plumbing connections - All areas should be repaired.

Recommendation: Contact a qualified plumbing contractor.

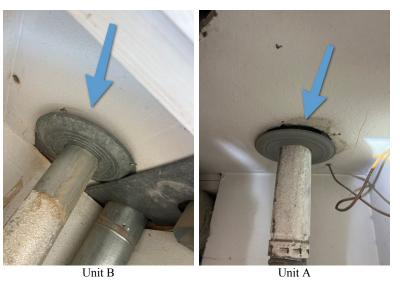
Flue collar not properly attached or missing at ceiling.

Recommendation: Contact a qualified plumbing contractor.

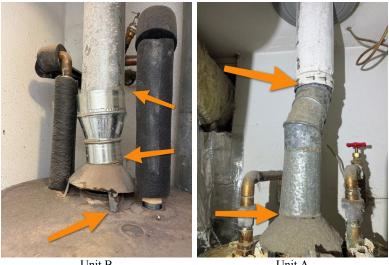
Flue/Vent is loose, damaged or poorly connected - This can result in flue gases escaping - Recommend repair.

Recommendation: Contact a qualified plumbing contractor.

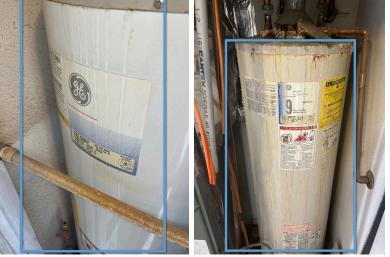
Evidence of past water leakage around water heater. At time of inspection area was dry.

Recommendation: Recommend monitoring.

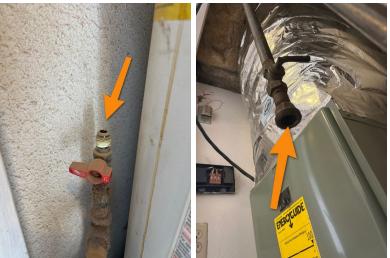
Gas line is not properly plugged - Valves alone have been know to fail - Recommend plug the line.

Recommendation: Contact a handyman or DIY project
